Inspector Homes LLC

SUMMARY REPORT

Client: John & Jane Doe
Inspection Address: 12345 W. Main Street, Anywhere, AZ 85...
Inspection Date: 1/24/2008 Start: 8:00 am End: 12:30 pm

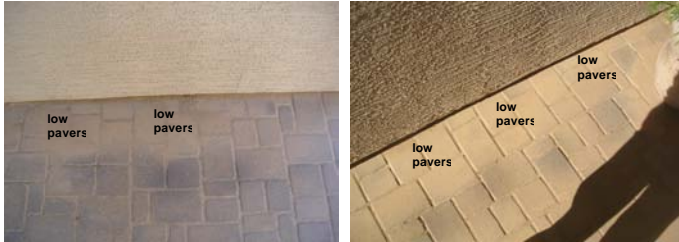
Water is puddling on the pavers in a couple of low areas of the front patio area. Specifically on the north garage wall near the west edge and also on the west wall of the patio area near the front entrance. There is evidence that water has puddled on the pavers in these spots because the pavers are a little lower. You may wish to remove the pavers and install additional sand, replace the pavers and eliminate the low areas so that water properly sheds off the front patio area. Another option is an area drain.

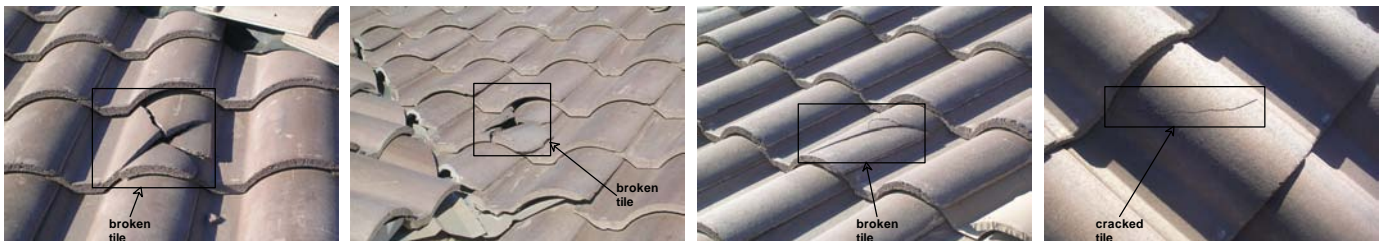
There are 5 cracked, 4 broken, and 21 chipped tiles that should be replaced some of which are potential water penetration issues. According to Workmanship Standards for Licensed Contractors put out by the AZ Registrar of Contractors "chips larger than a quarter are unacceptable and should be replaced by the contractor". The affected tiles are located as follows: SOUTH ROOF: Above SE undershot: cracked 5 rows from the bottom and 3 left of valley; chipped 2 below the top ridge and 2 from the east edge; EAST side of garage: broken 3 from the top and 6 from the south edge; above the garage door with the south facing: cracked 4 from the top and 2 from the west edge; above laundry room and the west side: cracked 2 from the bottom and 2 left of garage valley; chipped 2 from the bottom and 7 left of garage valley; right of and behind the front entrance area: broken 6 from the top and 1 left of the valley; left of and behind front entrance: broken 5 from the top and 3 left of valley; East side of front bedroom: 3 chipped top ridge 9, 10, & 11 from the south edge; 2 chipped 3 from the top and 1 & 4 right of the O'Hagin vent; broken 3 from the top and 2 left of the O'Hagin vent; chipped 4 from the bottom and adjacent the south edge; near the house top ridge: cracked 6 from the top and 8 from the west edge; NORTH ROOF: all the following are chipped tiles: bottom row 4 from the east edge; 2 from bottom and 8 from east edge; 3 from bottom and 8 from east edge; 10 from bottom and adjacent east edge; 3 from top and 9 from east edge; 7 from bottom and 2 right of east parapet wall; 5 from bottom and 6 right of east parapet wall; 3 from bottom and 5 right of east parapet wall; 8 from top and 18 from west edge; 6 from top and 12 from west edge; bottom row and 7 from west edge; 2 from bottom and 2 & 6 from west edge; cracked tile 4 from bottom and 3 left of east parapet wall.

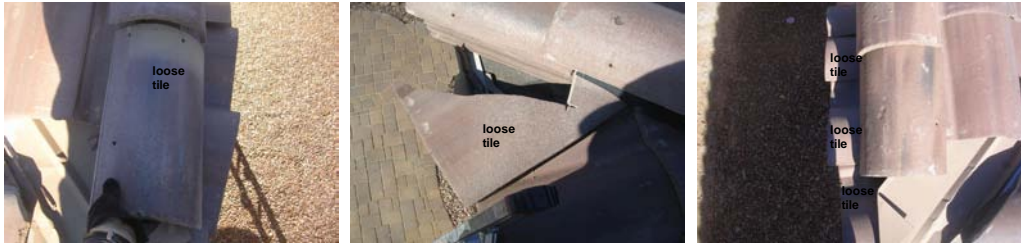
Six tiles are loose which should be secured. They are located as follows: 2 at the SE undershot; 3 at the SW

undershot and 1 at the lower left SW corner of the garage (south side).

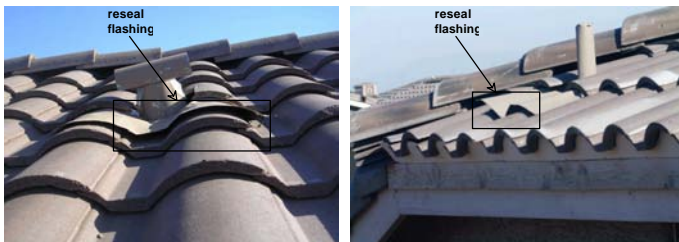
The roof flashings need to be sealed or serviced. Specifically: The exhaust vent flashing at the SW corner above the guest bathroom; also on the high peak shaped like a triangle on the west side is a plumbing vent flashing that is up.

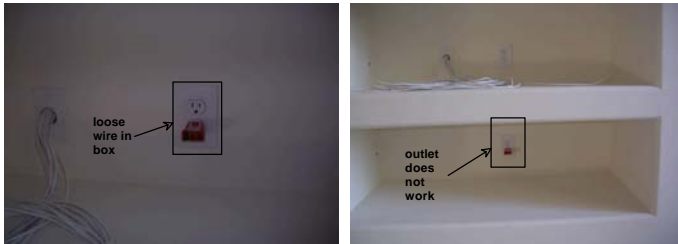
On the right side of the entertainment center shelving the upper outlet adjacent the low voltage cable wiring has a loose wire as it flickers on and off; the outlet in the box beneath this outlet does not work. This should be referred to an electrician for repair.
